REEDER RESERVOIR STUDY

Prepared for
City of Ashland, Oregon

February 25, 2008

APPENDIX B HOSLER DAM OUTLET STRUCTURE INSPECTION SUMMARY (JULY 20, 2007)
HOSLER DAM OUTLET STRUCTURE GATE INSPECTION SUMMARY (NOVEMBER 8, 2007)
CD CONTAINING A DIGITAL VIDEO RECORD OF EACH INSPECTION
(conducted and prepared by Advanced American Construction, Inc.)

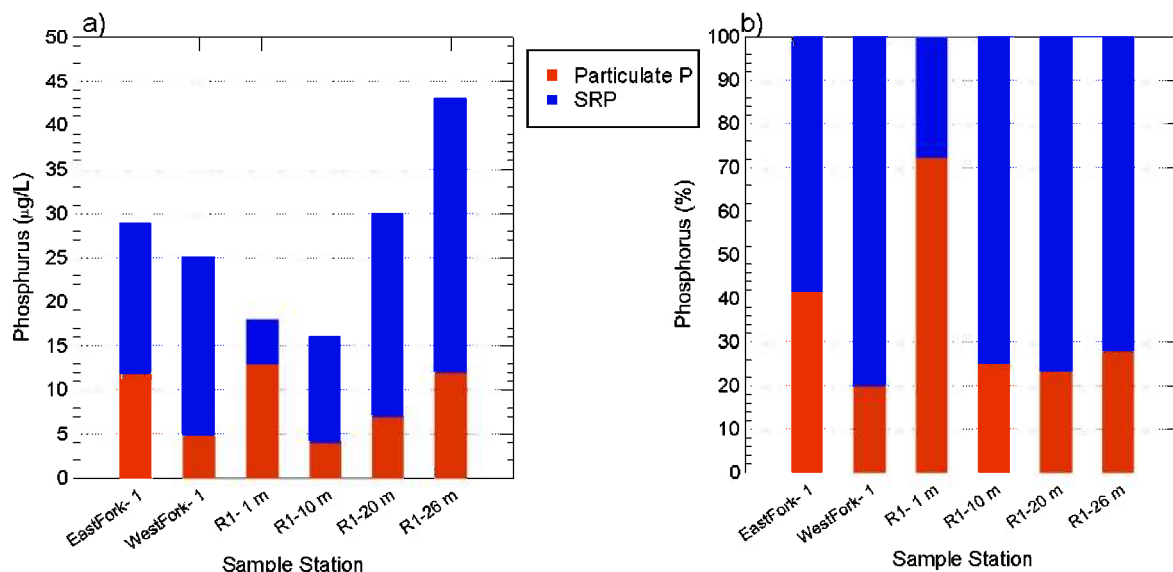
Comparison of in-reservoir nutrient concentrations with inflow nutrients on June 27th revealed that both East Fork and West Fork total phosphorus concentrations were high (>20 µg/L) with respect to conditions required for algal productivity, and that 60-80% occurred as SRP, a form readily available for algal uptake (Figure 3a,b). Concentrations in the upper 1 m and 10m layers (R1-1m and R1-10m, Figure 3) or epilimnion of the reservoir (the epilimnion is the lighted and mixed layer where the majority of algal production occurs) decreased from those observed in tributaries, likely as a result of settling and algal uptake (see particularly the proportional decrease of SRP in the 1 m layer indicating algal uptake). As shown above in the profile data, the 20 m and 26 m layers showed increased TP with the majority occurring as SRP (Figure 3b).

Figure 3. Reeder Reservoir and East and West Forks of Ashland Creek phosphorus concentration (a) and percent phosphorus (b), Station R1 June 27th, 2007.

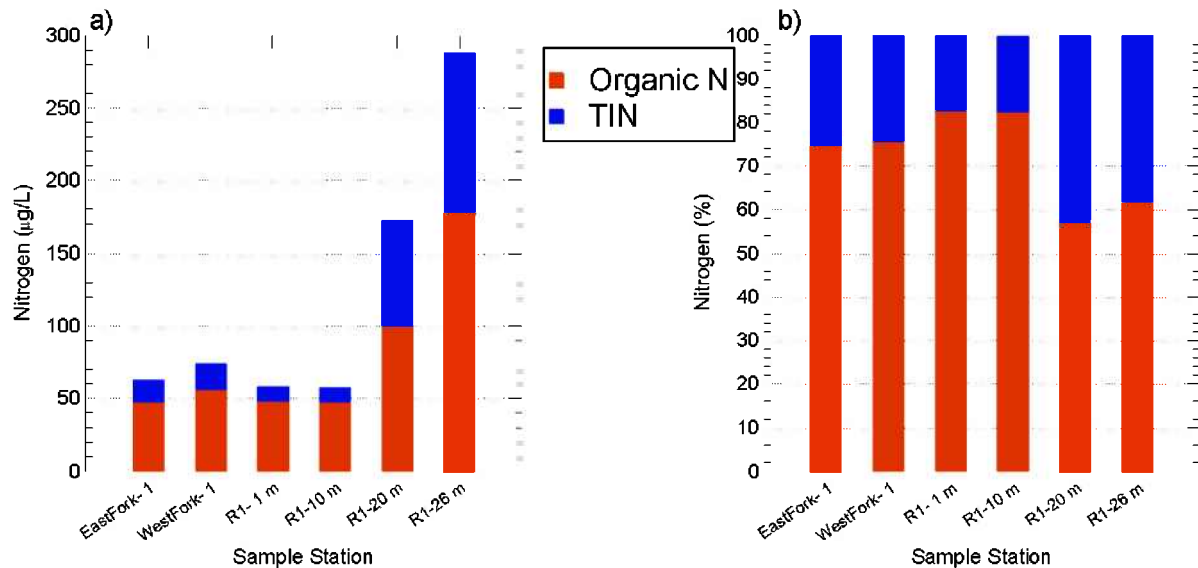
In contrast, East Fork and West Fork nitrogen concentrations were very low with respect to conditions required for algal productivity, and TIN (the total of NH_4 and NO_3 , the forms readily available for algal uptake) was below laboratory detection levels (Figure 4a,b). Reservoir TIN levels remained below detection at both the 1 m and 10 m layers, and then increased substantially in the 20 m and 26m layers, as did organic N.

Figure 4. Reeder Reservoir and East and West Forks of Ashland Creek nitrogen concentrations (a) and percent nitrogen (b), station R1; June 27th, 2007. (Note that when values are below laboratory detection limits values are entered as ½ of the detection limit; the detection limit for TIN is 50 µg/L and is 10 µg/L for both NH_4 and $\text{NO}_3\text{-NO}_2$).

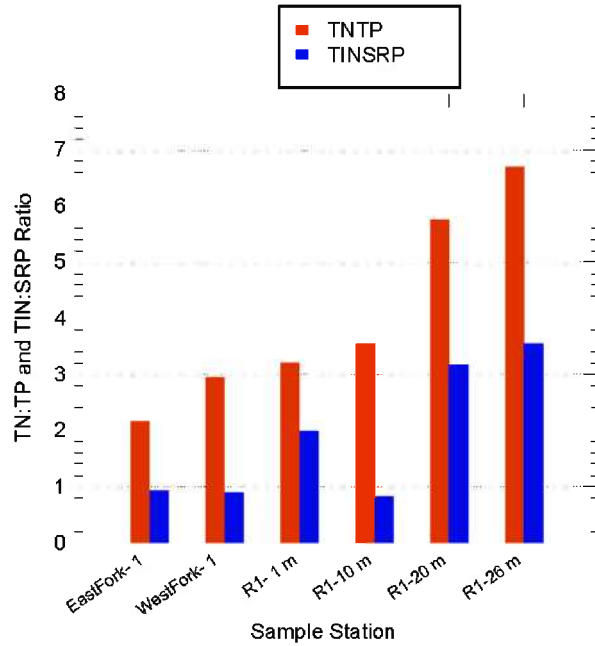
Such conditions of relatively high TP and SRP combined with low TN and TIN equated to TN:TP ratios <3 and TIN:SRP ratios <1 in the East and West fork tributaries (Figure 5). Such low ratios, along with available SRP (see Figure 3a), generally favor nitrogen-fixing blue-green algae. These algae are not dependant on ambient nitrogen concentrations, but rather can obtain nitrogen directly from the atmosphere.

Figure 5. Reeder Reservoir (R1) TN:TP and TIN:SRP ratios compared to those occurring in the East and West Forks of Ashland Creek, June 27th, 2007.

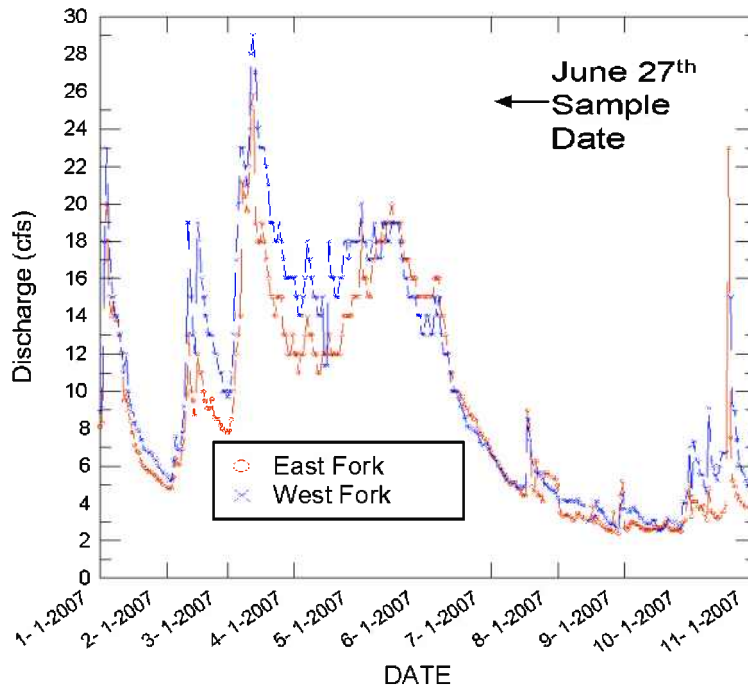
Figure 6. East Fork and West Fork Ashland Creek discharge into Reeder Reservoir, Jan-Oct, 2007. Data were downloaded from USGS: <http://waterdata.usgs.gov/OR/nwis/current/?type=flow>.

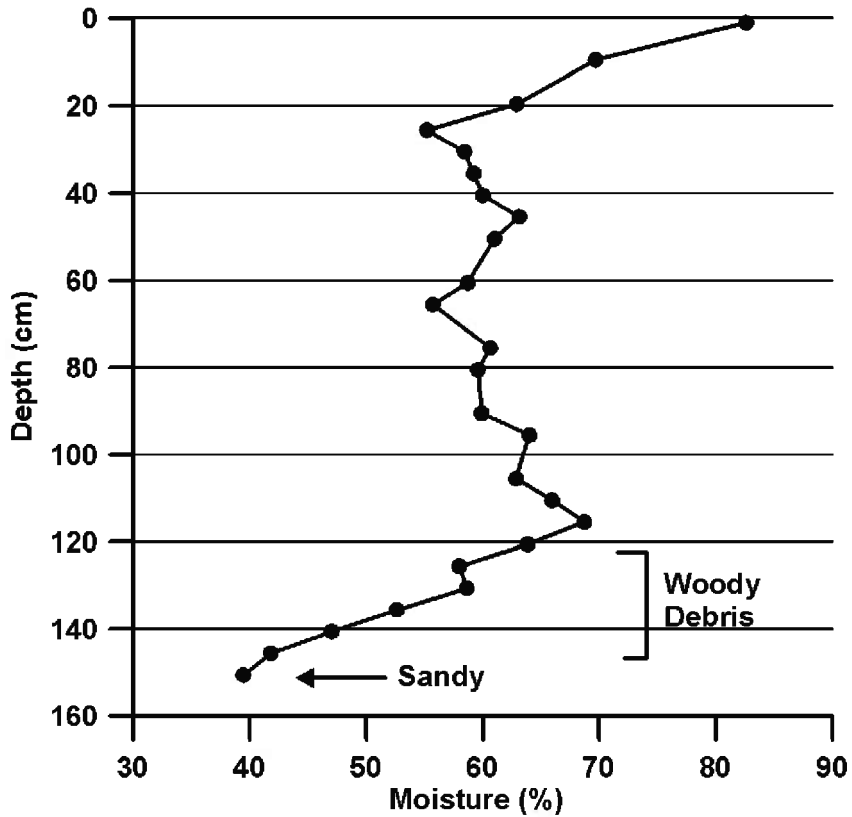
The moisture content of the two sediment cores illustrates complex patterns in sediment composition (Figures 10 and 11). The upper 25 cm of both cores were similar with respect to both physical appearance and moisture content. However, the appearance of the two cores below this depth differed considerably. The physical appearance of Core 1 below 25 cm remained relatively similar to the surficial sediments down through 120 cm, with the exception of a large piece of wood fiber at 95 cm (Figure 12a). Below 120 cm, much of the sediment included numerous large piece of woody debris (Figures 12b,c). The bottom interval of Core 1 contained a substantial amount of sand (Figure 12d). The textural classes for Core 1 are reasonably consistent with the water content and physical observations in which clay content was low throughout the core and increasing amounts of sand were present, especially below 120 cm (Figure 13).

Figure 10. Moisture content of sediment from Core 1. Locations of notable changes in sediment composition are noted.

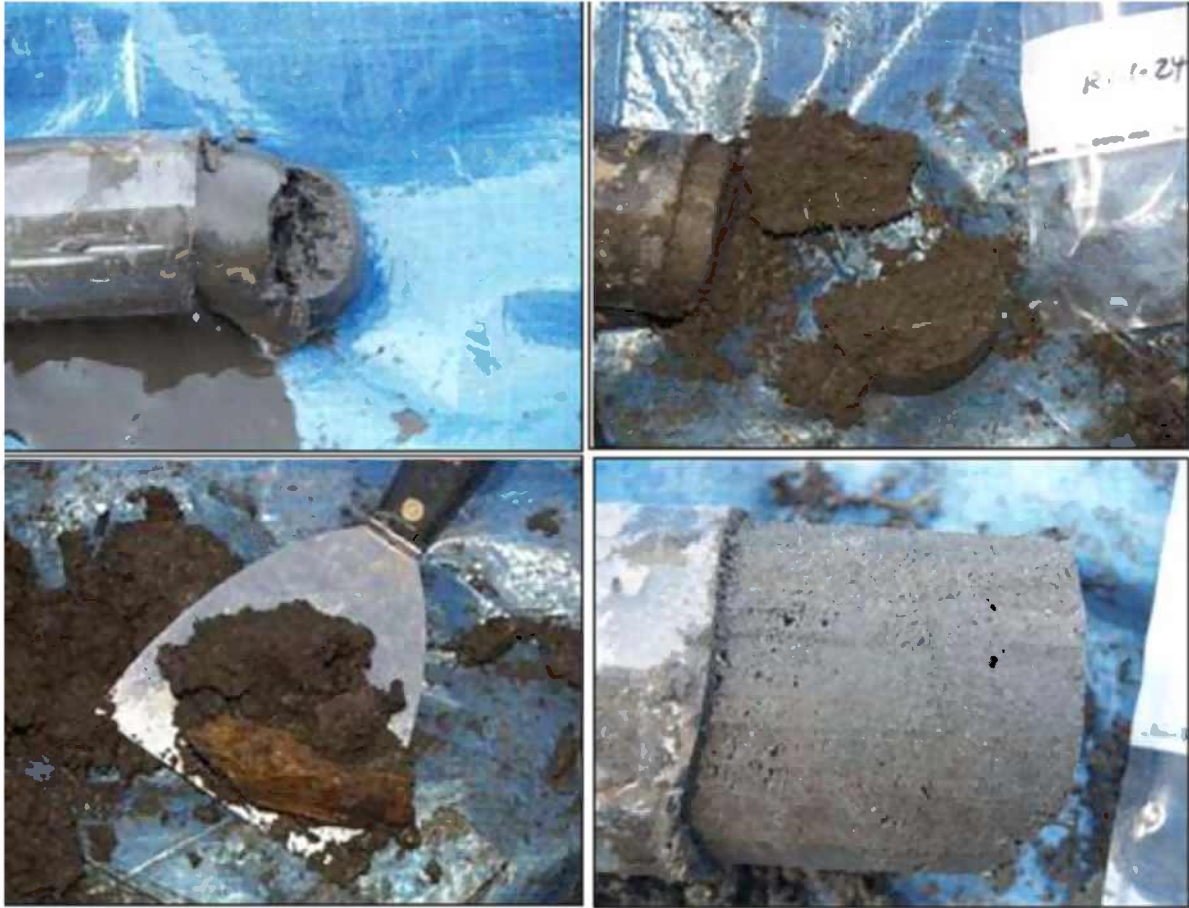
Figure 12. (a) Upper left shows sediment from the top of Core 1, illustrating its fine, organic texture and lack of cohesiveness. (b) Upper right shows large piece of woody debris at 95 cm. (c) Lower left shows small, numerous pieces of vegetation and larger woody debris and comparatively low water content. (d) Lower right shows bottom of core with higher sand content.

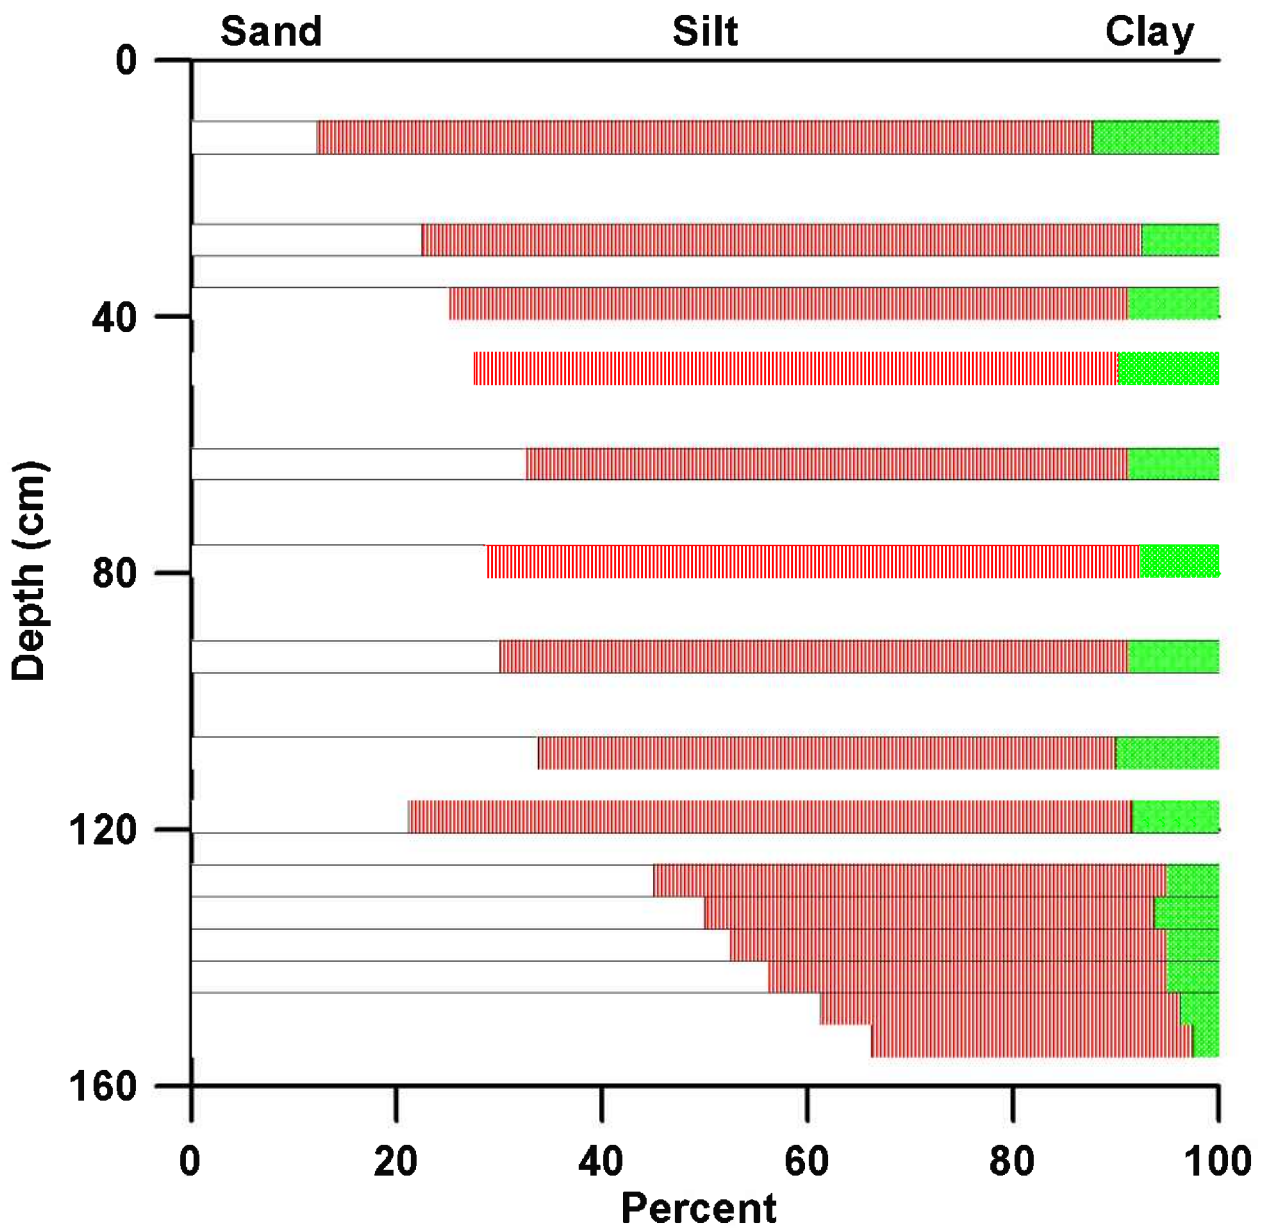
Figure 13. Textural classes for the sediment in Core 1.

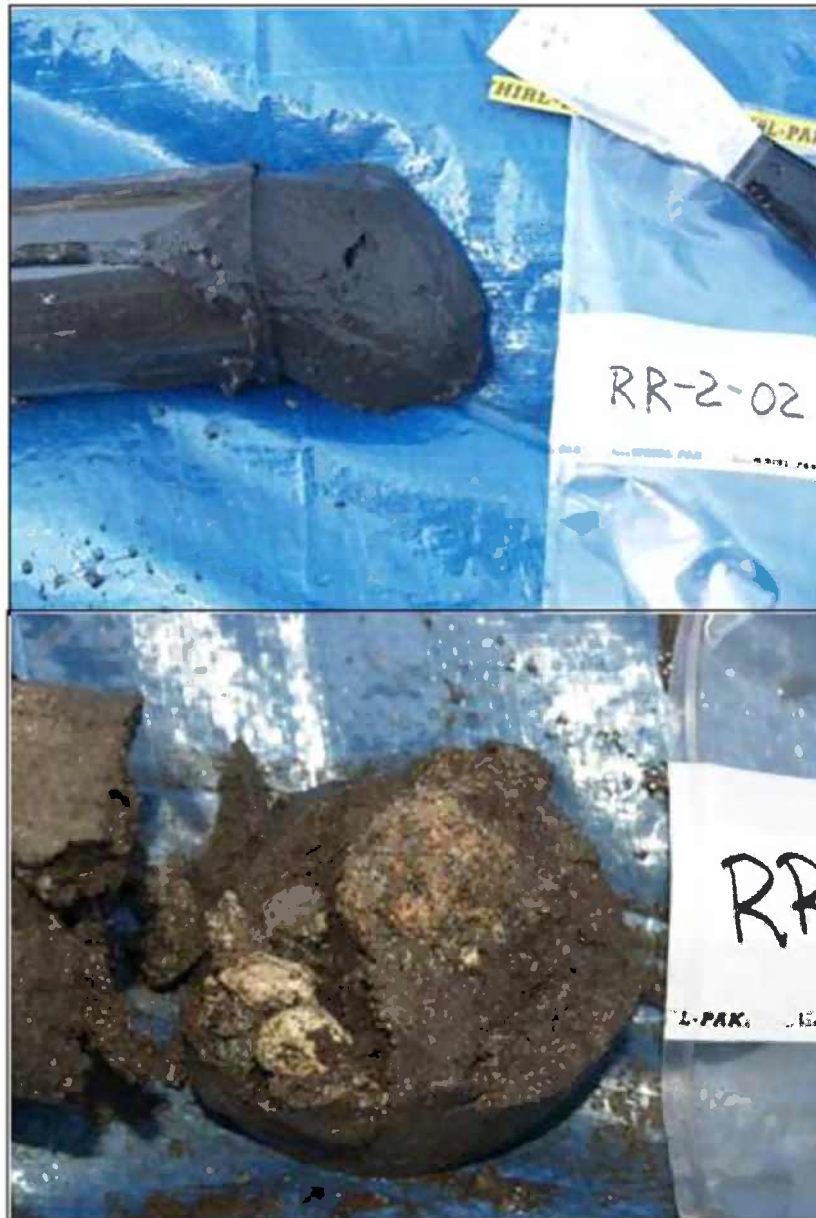
Although the surficial sediments in the two cores were similar to one another, the deeper sediments in Core2 differed substantially from those in Core 1. The sediments in Core 2 did not contain woody debris. Instead the dominant material included small granitic rocks, some over 30 mm in diameter (Figure 14). Consequently, the water content in the middle depths of the core was sharply lower (Figure 11). The information on the textural classes in Core 2 are similar from top to bottom (Figure 15), however this is somewhat distorted by the omission of the rocks from the textural analysis.

Figure 14. (a) Top shows the second interval from Core 2, representing the material from 7-14 cm. (b) Bottom shows the rocks present in the sediment from 49-56 mm. Smaller rocks were present in the next lower interval.

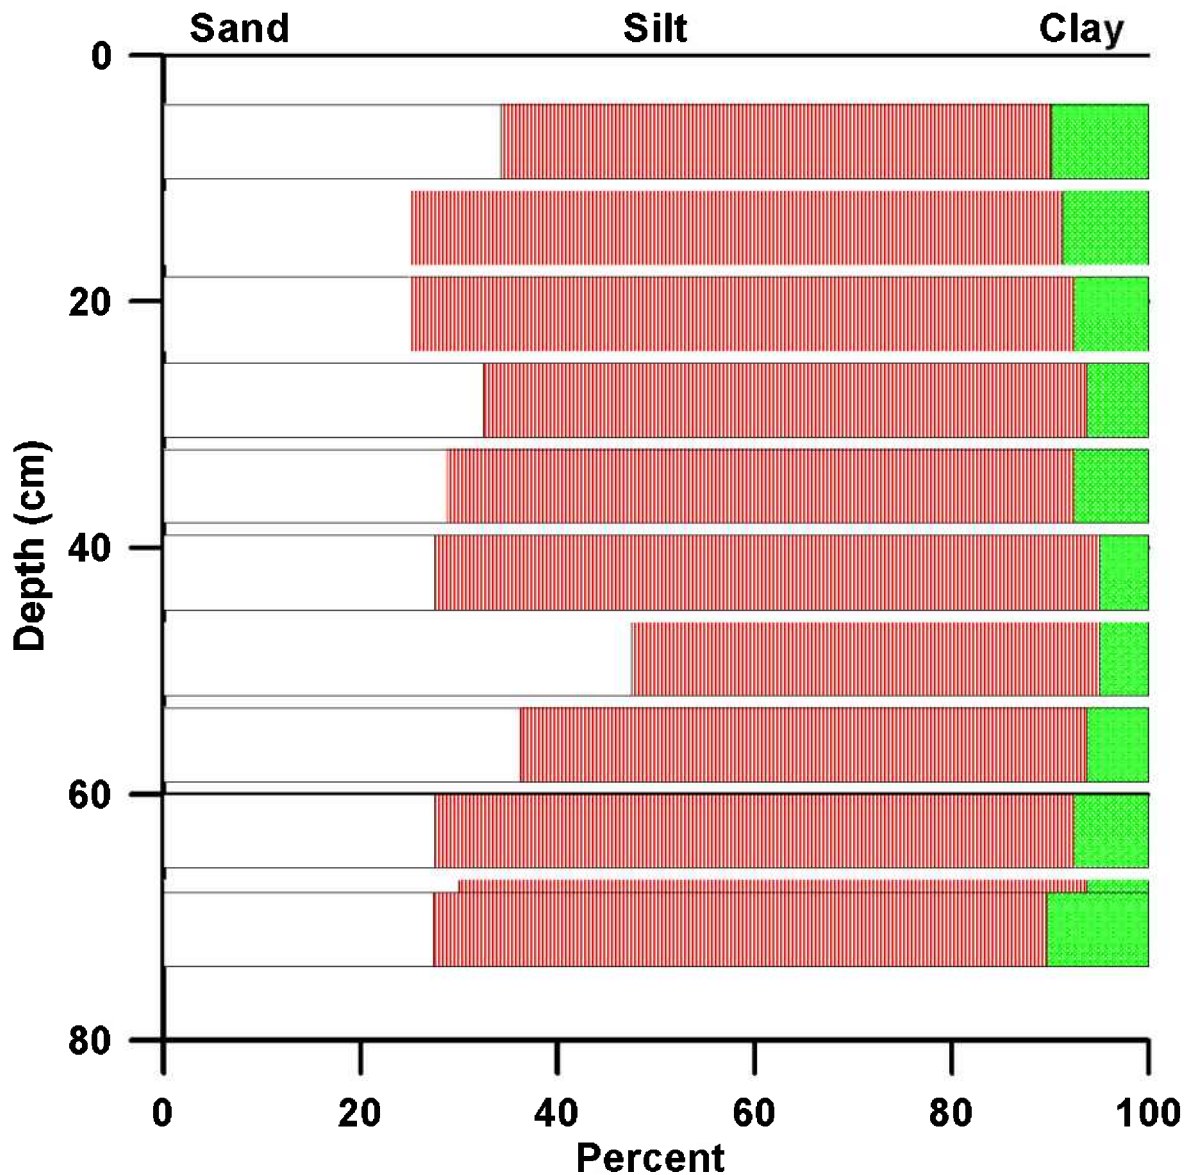
Figure 15. Textural classes for Core 2.

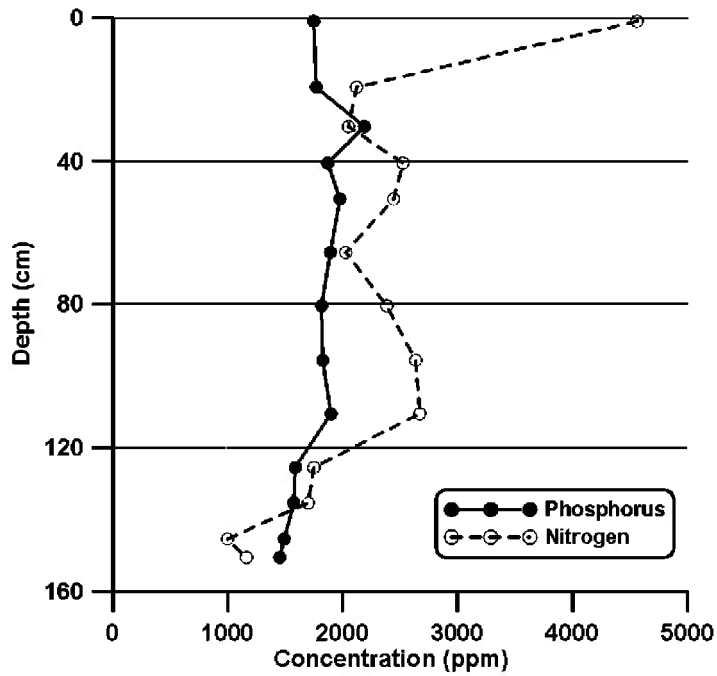
The chemistry of the sediments shows that the phosphorus concentrations in both cores ranged between 1000 to 2000 ppm (Figures 16 and 17). With the exception of an increase in phosphorus at ~ 30 cm, phosphorus concentrations are relatively stable and then decline below 120 cm. This is consistent with an increase in the proportion of sand and decrease in silt (Figure 13). Phosphorus concentrations in Core 2 exhibit a decrease between 40-60 cm, which is the region of the core with large numbers of rocks present (Figure 14). Both cores have high concentrations in the surficial sediments. Concentrations of nitrogen decline rapidly in both cores. Nitrogen values remain relatively stable from 20 to 120 cm, but decline throughout the bottom portion of the sediments. In contrast, concentrations of nitrogen reach a minimum ~ 50 cm and increase substantially at the base of the core.

Figure 16. Concentrations of nitrogen and phosphorus (dry wt) in Core 1.

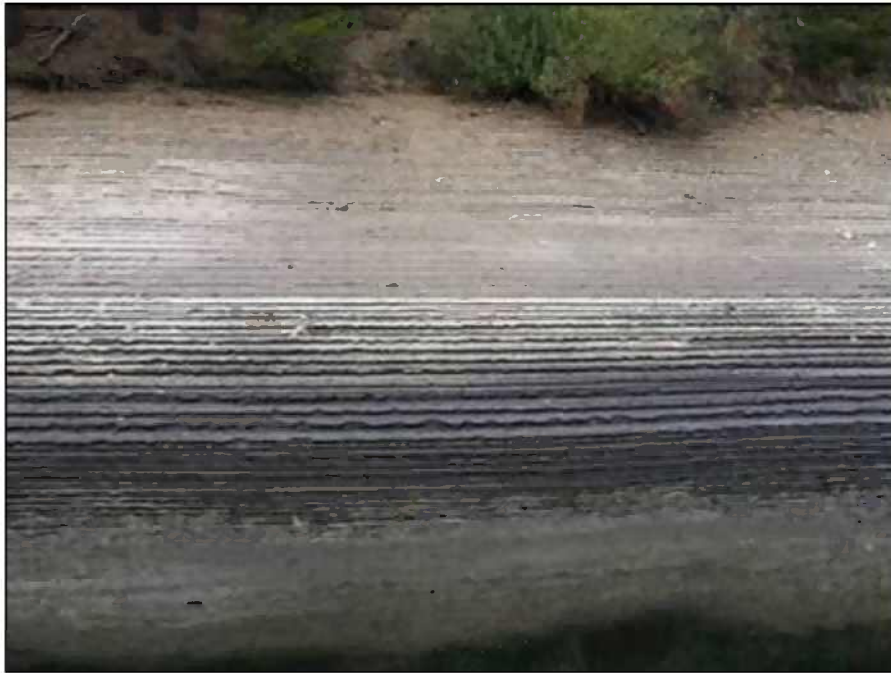
Figure 24. Erosional bands on the east shore of Reeder Reservoir created during drawdown. The light colored material in the middle is largely coarse sand comprised of “rotten” granite and the dark material is organic matter deposited during full-pool conditions. This image was taken on September 14, 2007, with the reservoir stage at 2851 ft (21 ft below full pool).

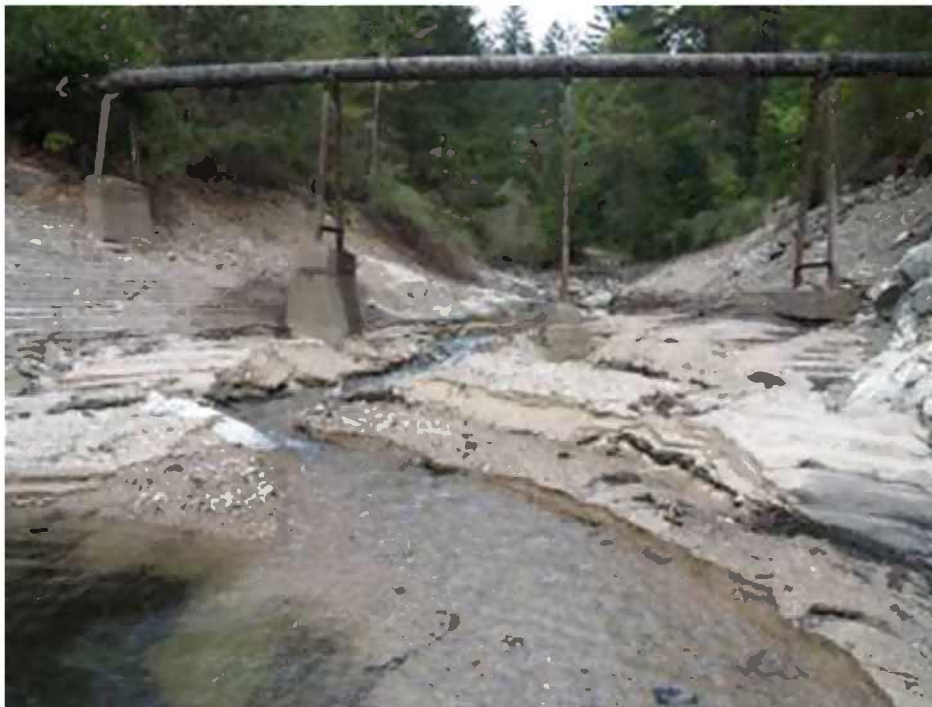
Figure 25. East Fork of Ashland Creek at the confluence with Reeder Reservoir, September 14, 2007. In contrast, the West Fork inlet contains a large deltaic formation comprised of much finer-grained material (Figure 26).

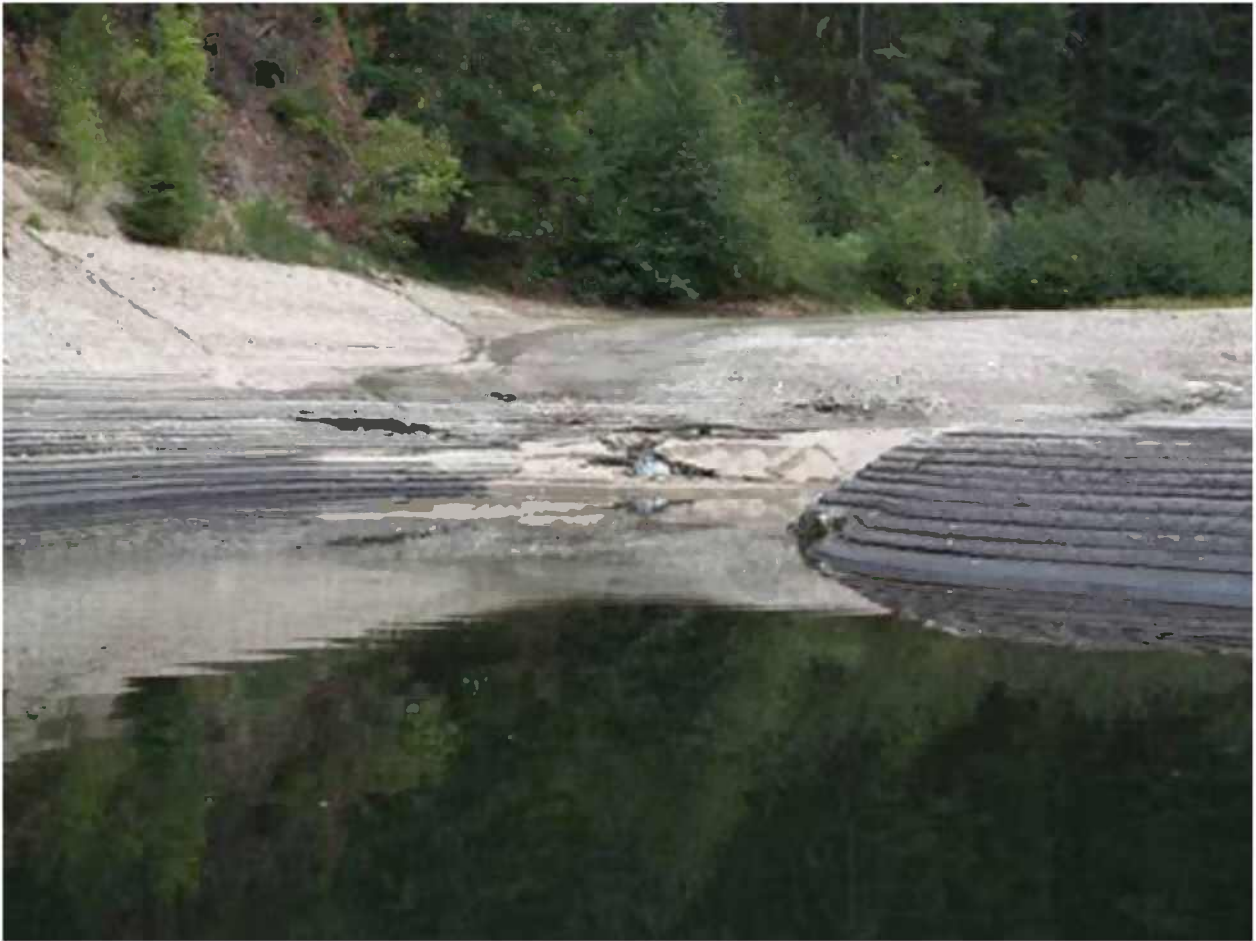
Figure 26. West Fork of Ashland Creek at the confluence with Reeder Reservoir, September 14, 2007.
